TS-1071	Replacing EMAC Chip In VX Series	Document Owner: Service Department	Effective Date: SEP-28-2021	Page 1 of 4
----------------	---	--	---------------------------------------	--------------------

This document provides steps to remove and replace an EMAC chip in the carrier board in a VX2/VXL. This can be referenced when troubleshooting a communication issue and the chip is potentially deemed bad.

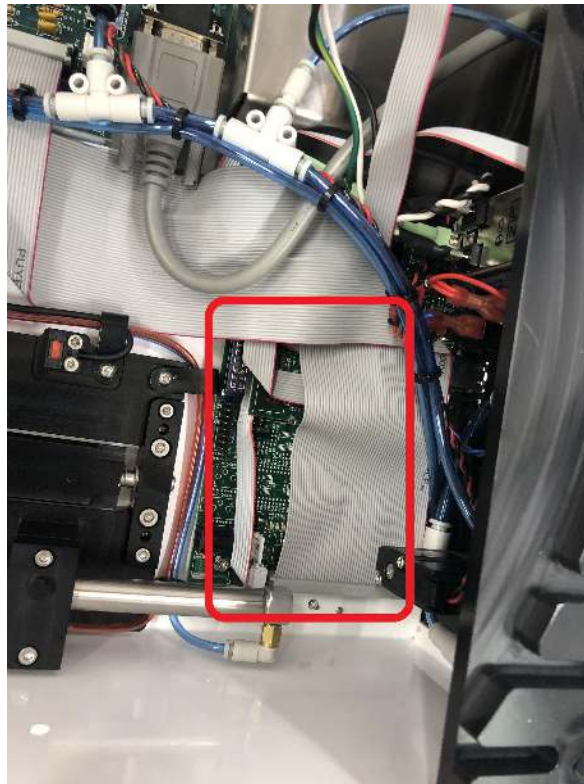
Figure 1.

1. Ensure the instrument is turned off. If it is not, toggle the power switch on the control panel of the VX located on the right hand side of the machine
2. Locate carrier board, half of the board will be hidden by wiring (see picture below)

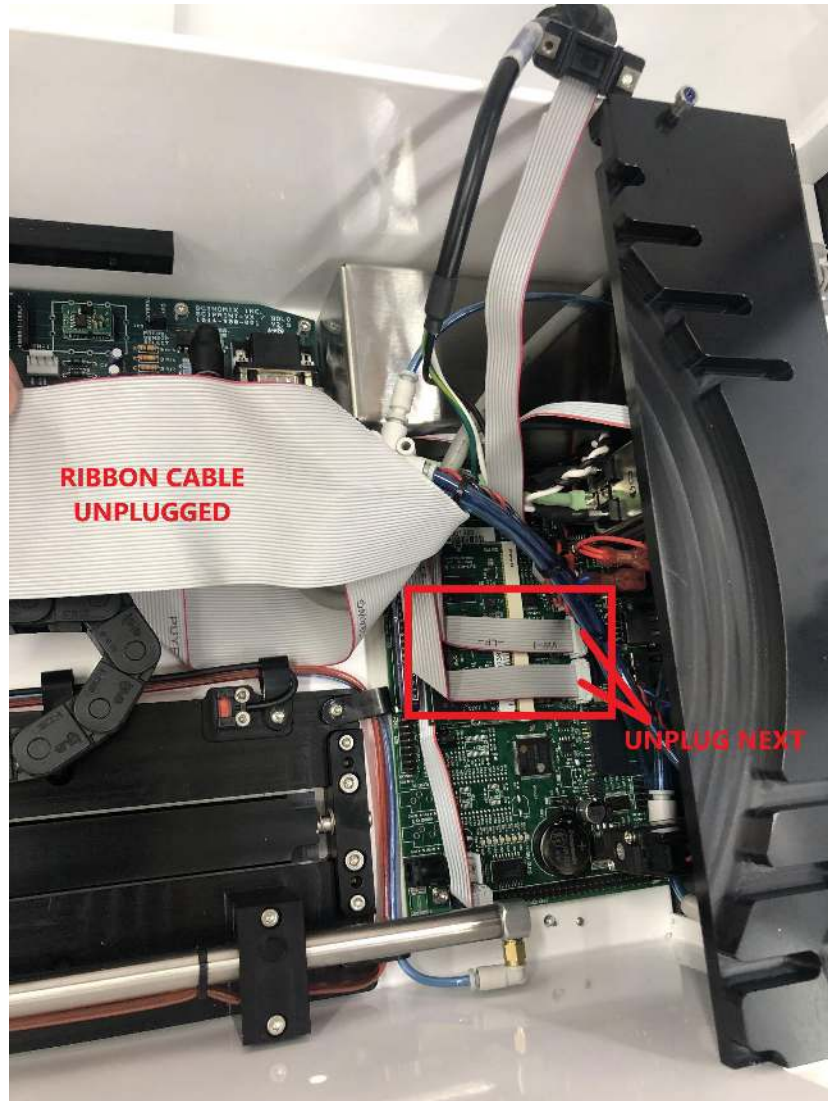
Figure 2.

3. Remove the ribbon cables shown in the pictures below to reveal the chip mounted to the top of the carrier board

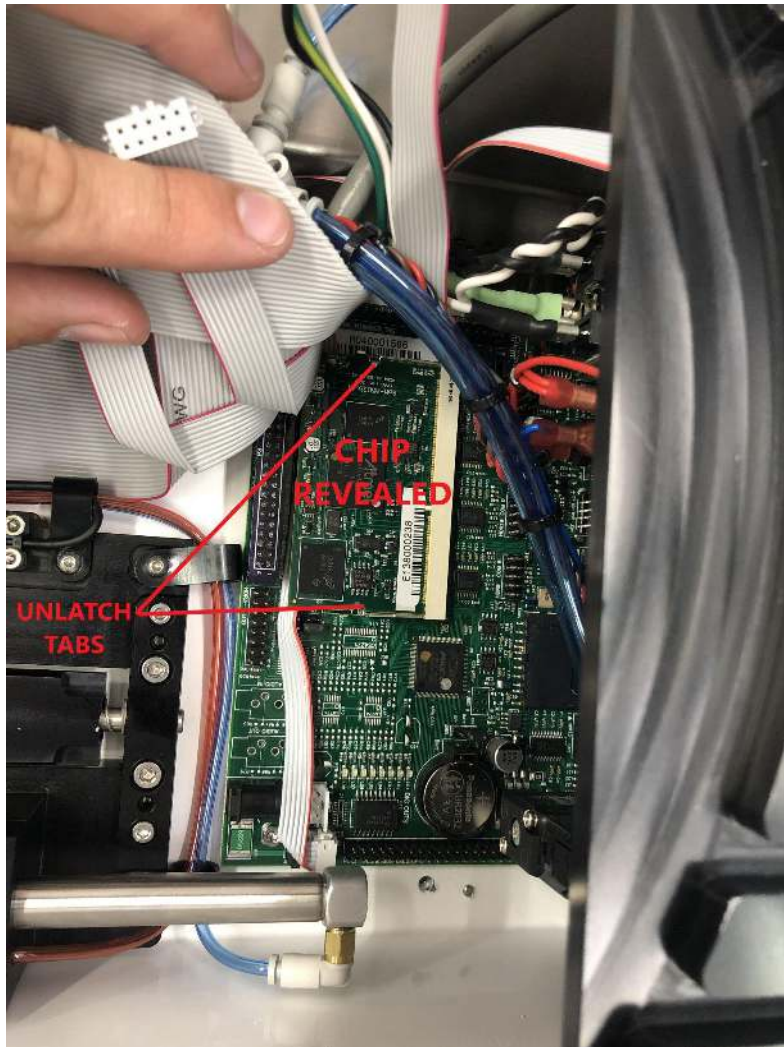
Figure 3.

4. Remove chip from carrier board by unlatching the tabs on either side and slower lifting the board away from the white pin reader. Do this process slowly as damage could occur if the chip is pulled or twisted if it is still latched or engaged in the reader.

5. See removed chip below - please package and have sent back to Scinomix
6. Locate new chip and prep for install - record serial number on white tag
7. Reverse steps for installing the replacement chip.
 - a. Insert chip into reader and push down until latches engage
 - b. Replace ribbon cables into respective ports
 - c. Verify all connections made
8. Replace printer
9. Turn on machine power
