<b>TS-1096</b>	<b>Replacing the Blue Air Knob</b>	<b>Document Owner:</b> Service Department	<b>Effective Date:</b> AUG-22-2022	<b>Page 1 of 3</b>
----------------	------------------------------------	--	---------------------------------------	--------------------

This document provides the steps needed to replace the air knob.

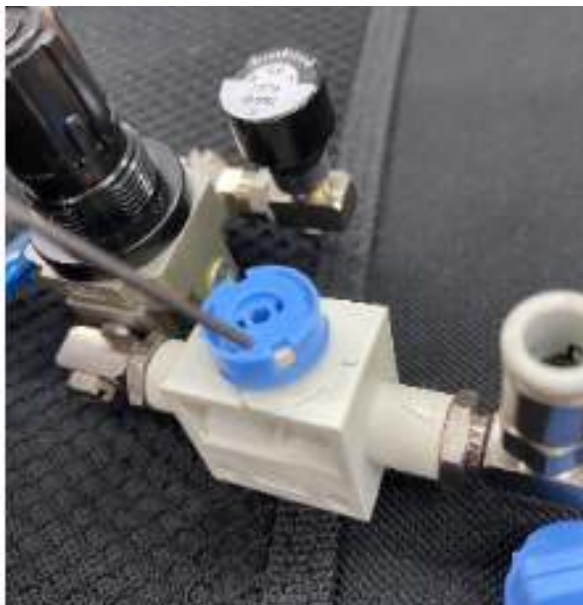
Figure 1.

1. Figure 1 below shows the valve with the cap removed, and in the engaged state. In this state, the cap cannot be placed back on because the switch is not aligned.

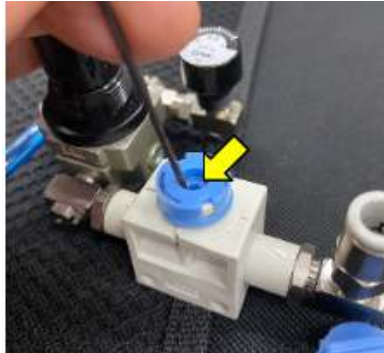
Figure 2.

2. Figure 2 below shows the inner switch depressed to allow the outer ring to turn.

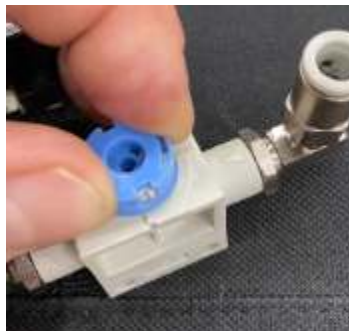
Figure 3.

3. Figure 3 shows the outer ring aligned with the internal notches to allow the cap to be replaced.

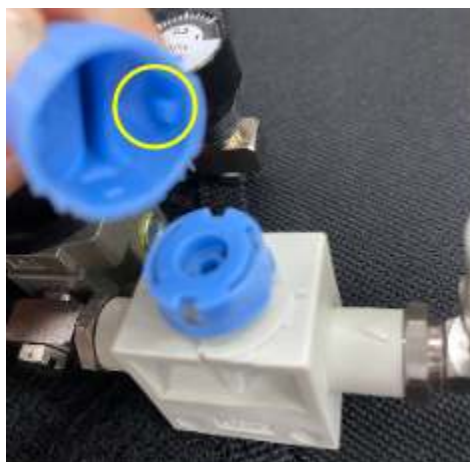
Figure 4.

4. Figure 4 shows the tabs inside the cap that need to be aligned with the notches.

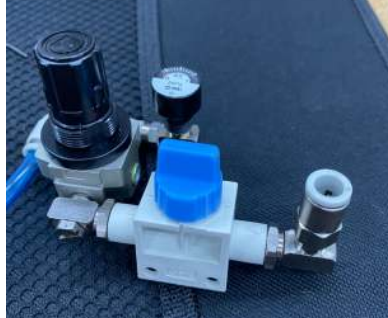
Figure 5.

5. In Figure 5 the cap is fully seated and in its operational form.
